Case Study 2 - Bedplate Fabrication

A client required us to blast and paint a bedplate to their own specification as shown below:

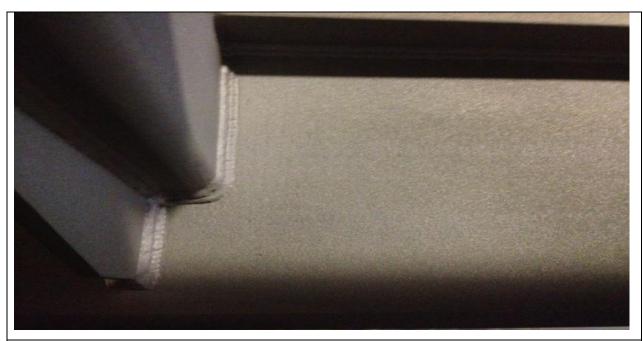
The bedplate was then moved in our blasting chamber where it was blasted to a Swedish Standard SA 2 %. Once blasted the blasters cleaned down (Removed any loose shot from the surfaces) and checked the bedplate for any areas that were missed during the blasting process, once the blasters were happy the bedplate was checked by a supervisor.

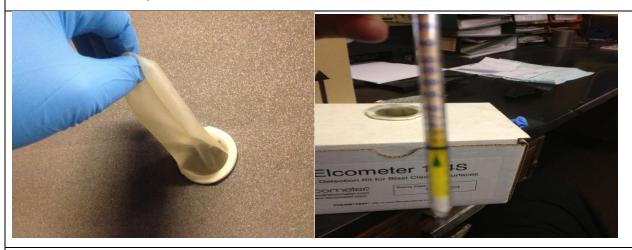
Salt Test – This test was performed using an Elcometer 134S which requires filling up a
latex sleeve with a sterile solition and applying the sleave with the solition to the
blasted steel for a period of 2 minutes. Once the sleave was removed from the blasted
surface a Titration Tube was incerted to the solution for a period of 90 seconds and the
reading was recorded.

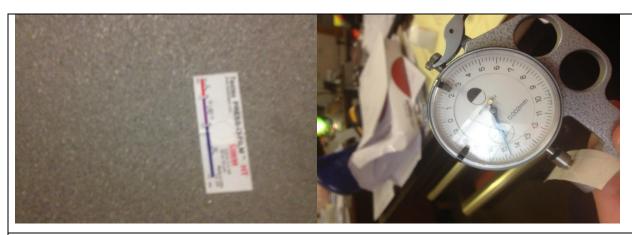
2. Testex – This involves using a pad and applying to the blasted surface, once applied the pad needs to compressed into the blasted surface. Once compressed against the blasted surface a reading of the profile was taken using a Elcomentre 124 and these readings were then recorded.

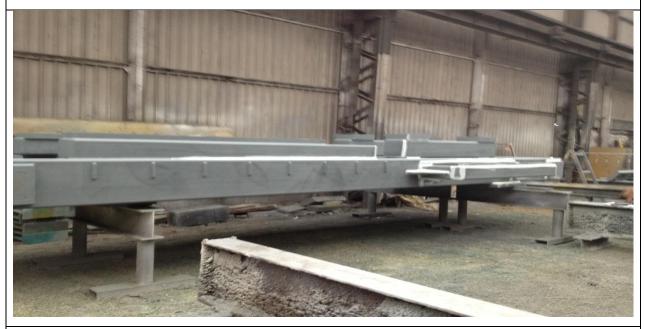
After the blasting had been completed and the necessary checks and tests had been carried out satisfactorily the bedplate was ready to be primed. This involved the painter cleaning the surface from dust using compressed air to clean out the bedplate. Once the bedplate was clean the bedplate was primed using a metallic rich epoxy primer.

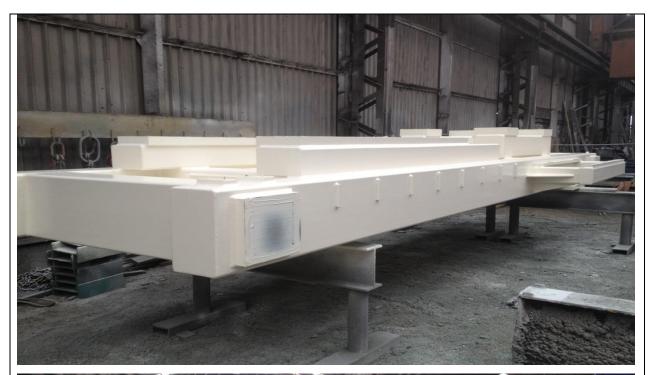
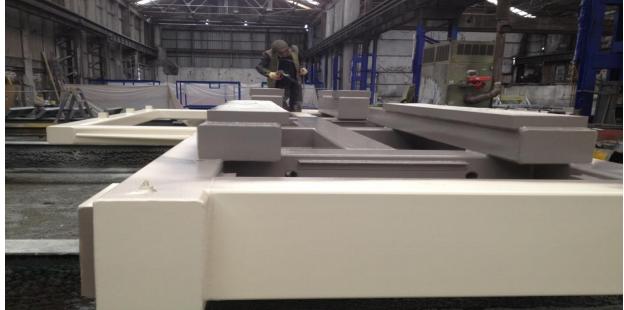
Once the primer had been applied and was given the required time to cure the next coat was applied, this was a high build glass flake epoxy (Interzone 505). This was applied with the appliaction of 2 full coats, we used contrasting colours of Off White and Grey as by doing so it is easier for the painter and inspector to identify any misses between coats. Due to the nature of the fabraiction all the welds and difficult areas were required to be stripe coated before full appliaction. A stripe coat is where areas receive a brush before reciceveing a full coat by airless spray, this is to ensure full coverage of the welded or difficult area.

During the appication of Interzone 505 various checks take place. These checks include the following:

- 1. Visual checks this is where the bedplate is checked for any missed areas between coats aswell as for any runs and sags which require to be rubbed back.
- 2. Dry Film Thickness (DFT) checks is where a gauge is used to measure the thickness of DFT of the paint, when areas are found to be low they are built up with more paint and when areas are grossly over thickness they are rubbed back.

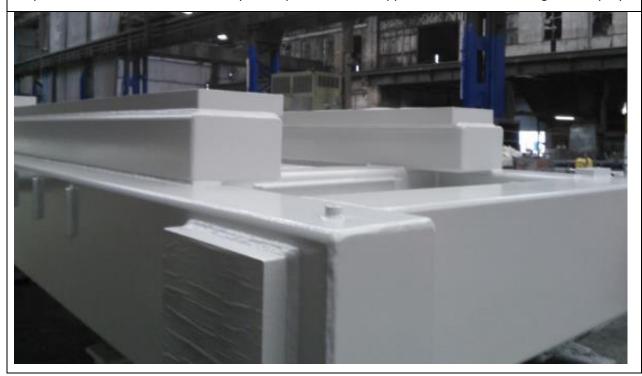
Application of the final coat expoy acrylic isocyante free (Interfine 691) is carried out once the material is of a suitable standard; free from runs and sags and up to the required thickness. The top coat is again stripe coated into the difficult areas by brush prior to the full application of the coat using airless spray.
